## **Limited Visual Dam Safety Inspection Summary Report**

**MA-048**

**Olinda Reservoir**

**May 2006**

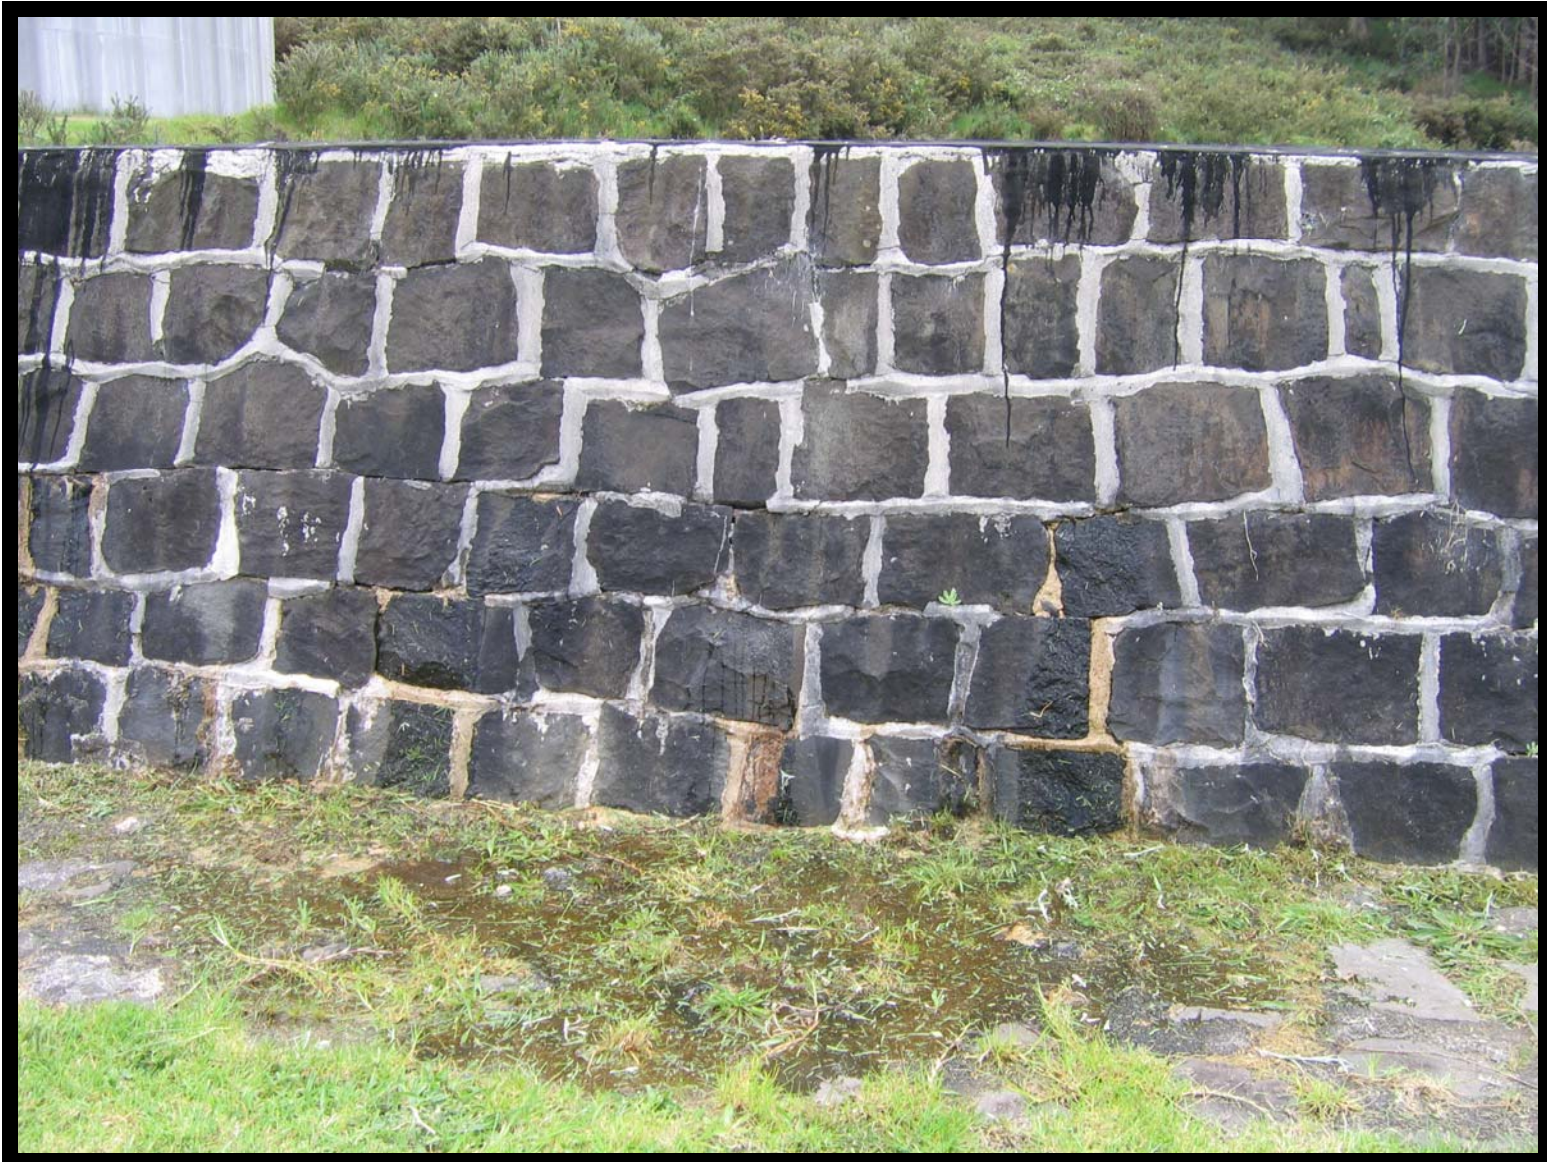
The downstream slope was approximately 1 on 2 slope and consisted of earth. The cover was grass that had been recently mowed. There was no erosion was observed at the downstream slope. Sinkholes were not observed on the downstream slope. Very slight seepage was observed of mortar joints at one point along the wall.

048 Seep at downstream wall - View of minor seep at top of downstream grouted rock wall.

Seepage: Seep Spot Number 1☐ Green Vegetation ☒ Wet or Muddy Ground ☐ Ponding Water ☐ Not Visible ☐ None Observed☐ Flowing, Description: SLIGHT SEEPAGE OF MORTAR JOINTS AT 1 PT ALONG WALLWater Clarity: ☐ Clear ☐ Some particles ☐ Muddy ☐ Other: \_\_\_\_\_

- a. The downstream slope appeared to be in satisfactory condition, no corrective actions are required at this time.
- b. Seepage water observed at mortar joints. Monitor any significant changes in seepage.

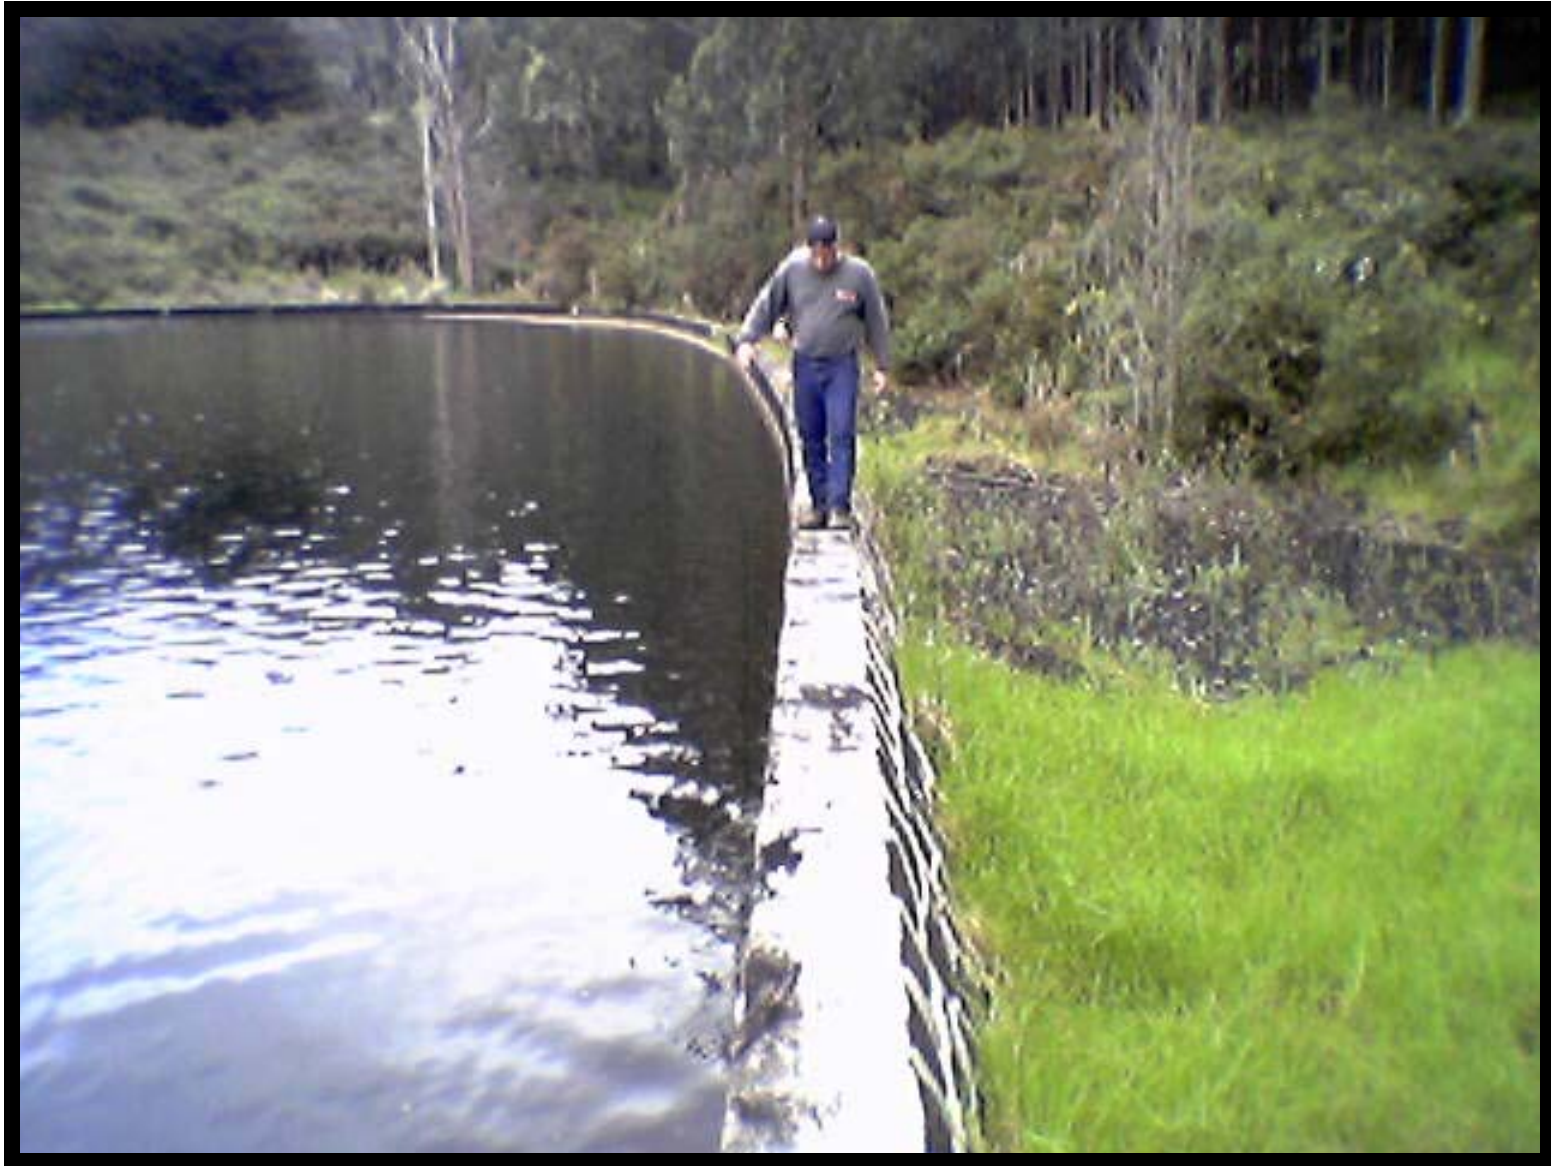
048 View of left side of reservoir wall

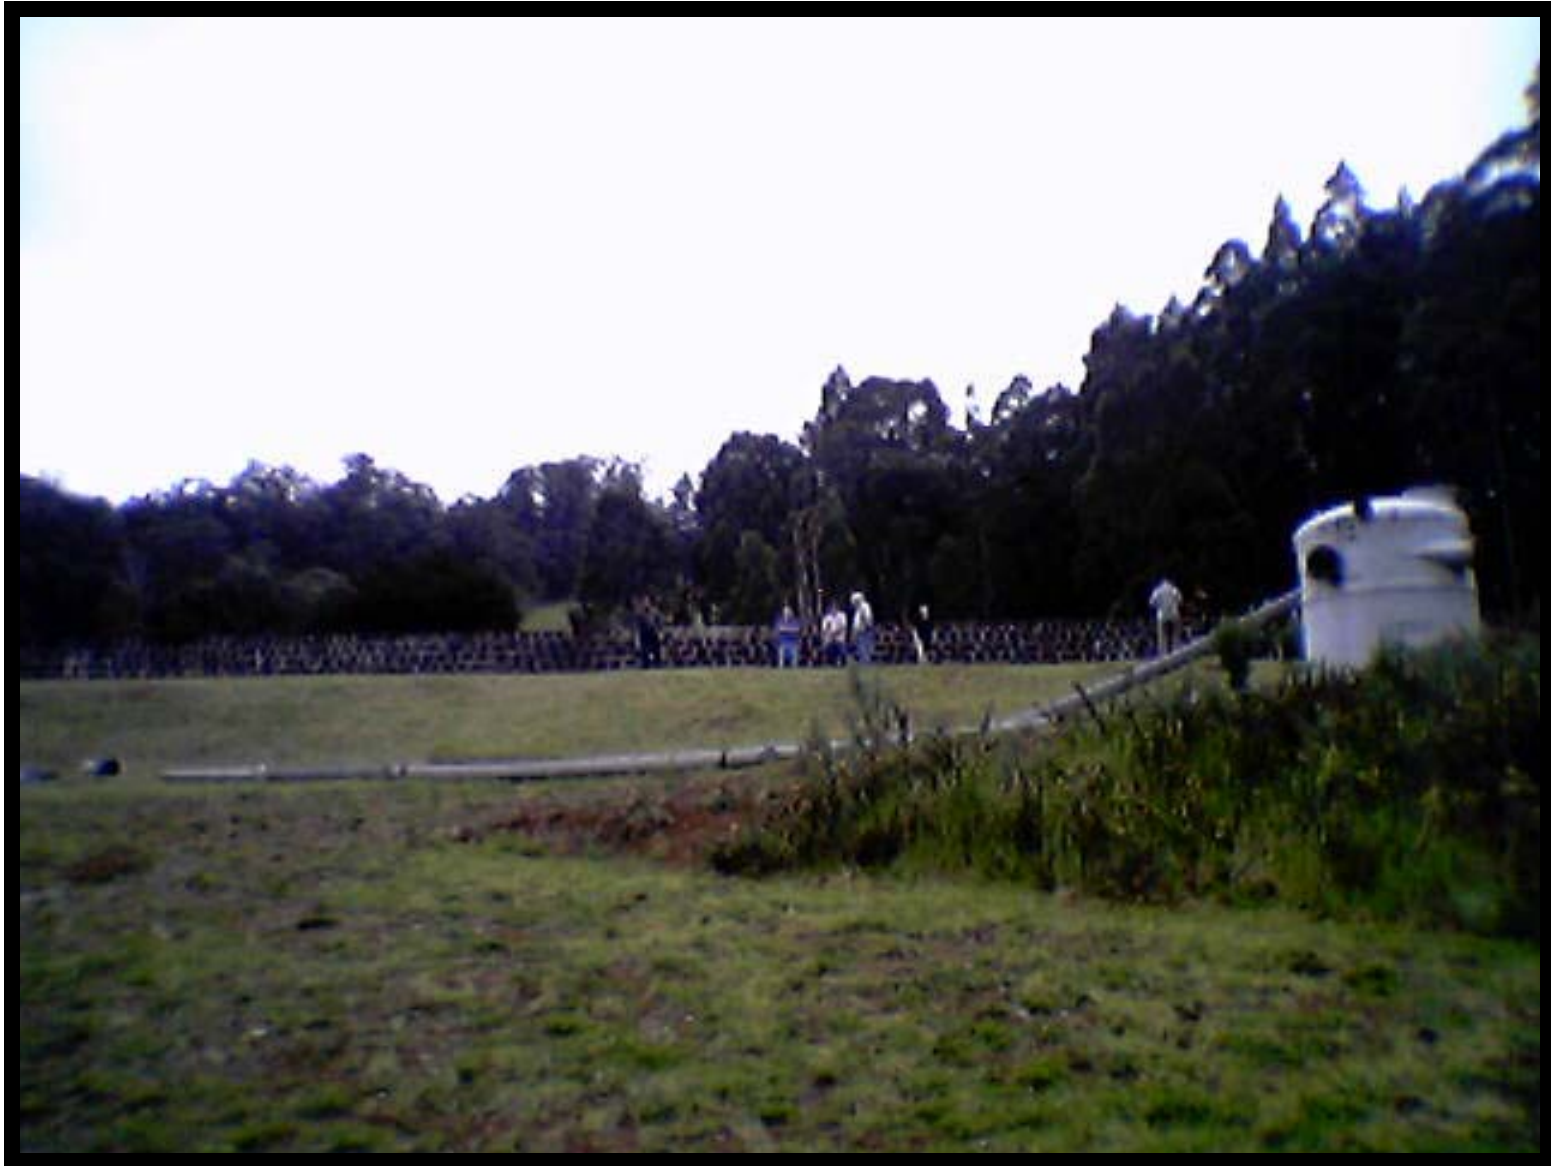
048 View of downstream slope and wall - downstream earth slope and rock wall.

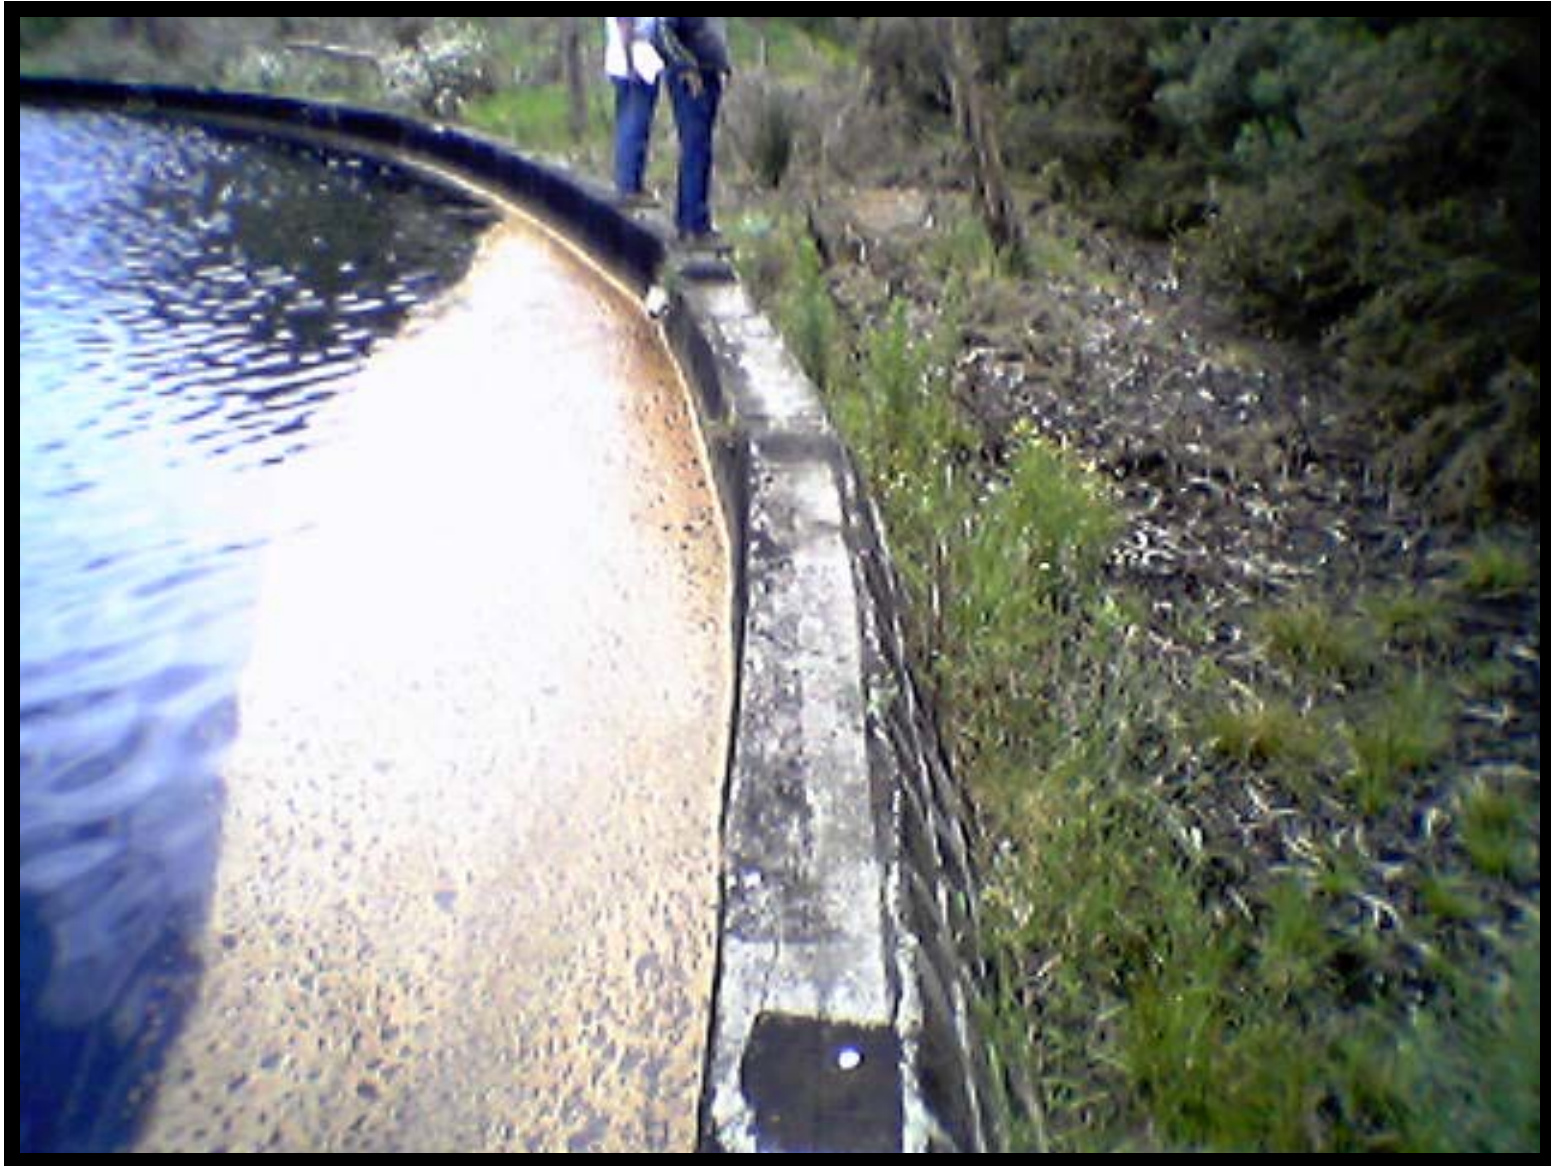
This spillway is a 2-inch notch in the rock wall of the reservoir. The rough dimensions were 3feet by 2-inches deep. The spillway approach was clear. There was no erosion observed near the spillway.

048 View of 2 inch spillway - wall section left side of reservoir

2) SPILLWAY IS NOT ADEQUATE IF POOL RISES SUDDENLY DUE TO UNCONTROLLED INFLOW. HOWEVER, ENTIRE TOP OF DAM ~~AND~~ AND ADJACENT IMMEDIATE SPILL ZONE IS GROUTED RIP-RAP.

- a. The spillway appeared to be in fair to poor condition and requires corrective action.
- b. Unclear is spillway is adequately sized. Spillway should pass probable maximum flood. Verify spillway capacity and take action as required.
